FIVE-YEAR REVIEW REPORT

FOR
PHOENIX-GOODYEAR AIRPORT (SOUTH)
SUPERFUND SITE
GOODYEAR, ARIZONA

September 2005

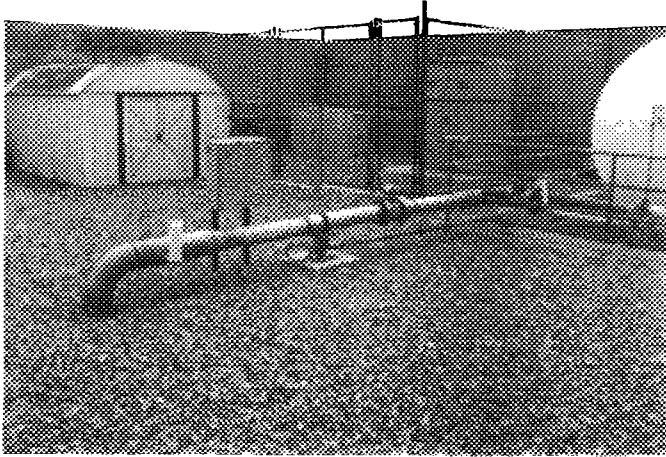
Photograph 1. Inlet piping at Subunit A Treatment System.

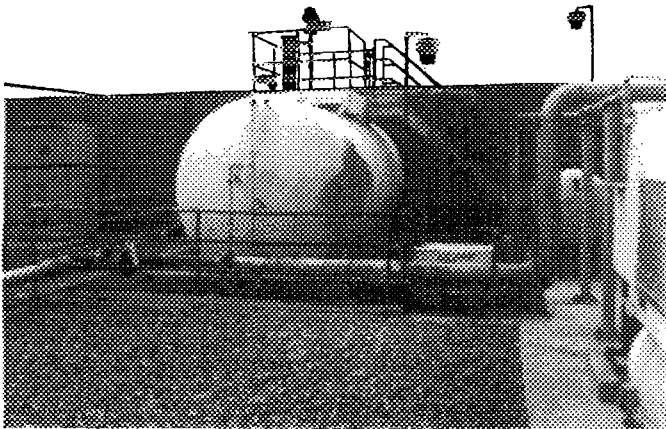
The Subunit A treatment plant was operating at the time of the site visit. The acid tank, air stripping tower, GAC system, and associated piping were visually inspected. The equipment generally appeared in good condition, although there was some corrosion apparent on the acid tank. The tank was located in a secondary containment pad.

Photograph 2. Acid tank and piping at Subunit A Treatment System.

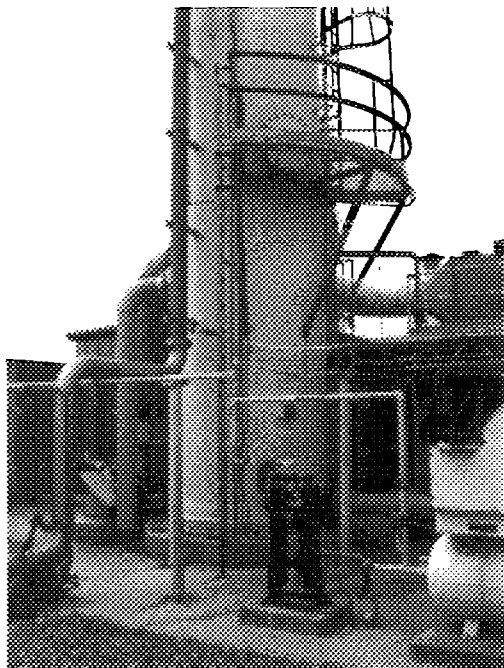
Photograph 3. Air stripping tower, Subunit A Treatment System.

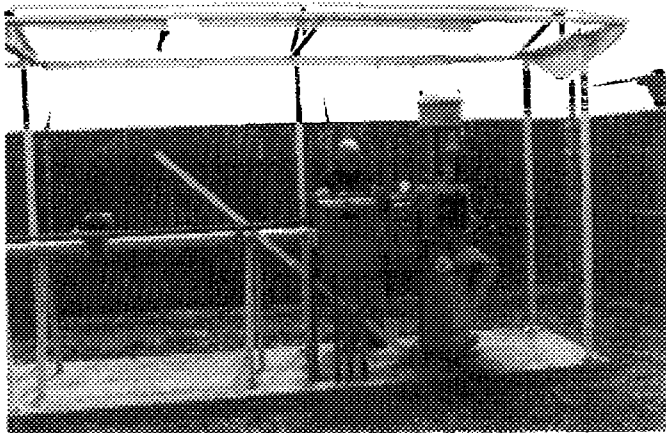
The Southern Subunit B/C treatment plant was operating at the time of the site visit. The extraction well E-201, the GAC vessels and associated piping were visually inspected and appeared in good condition, although there was a slight leak from the packing of the turbine

pump at E-201. The office contained all necessary project information. E-102, which extracts water from the northern Subunit B/C plume but routes water to the southern Subunit B/C treatment system, was also inspected. There was a larger leak from the packing at this well (see photo 10 in Appendix C). Site personnel stated that this pump has had problems in the past and would inquire as to whether the pump was covered under manufacturer's warranty. Injection well I-202 was offline because scaling within the well had reduced the injection capacity of the well. Due to this reduction in injection capacity, extraction well E-202 was also offline. These are considered short-term issues that do not affect the overall effectiveness of the remedy.

Photograph 8. Extraction Well E-201 (Southern Subunit C).

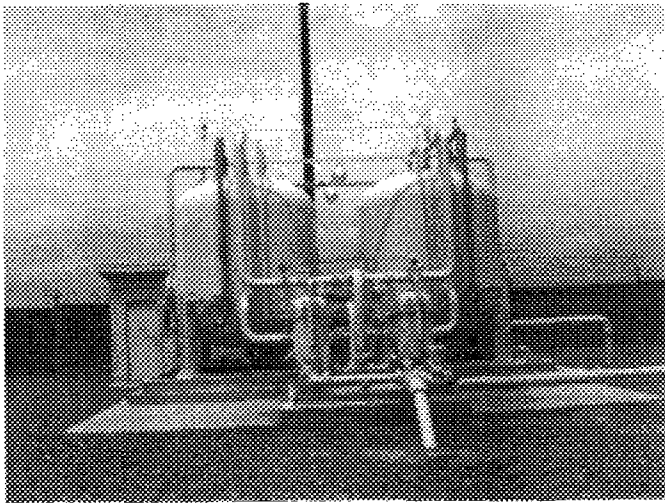
Photograph 9. Southern Subunit C GAC Treatment System.

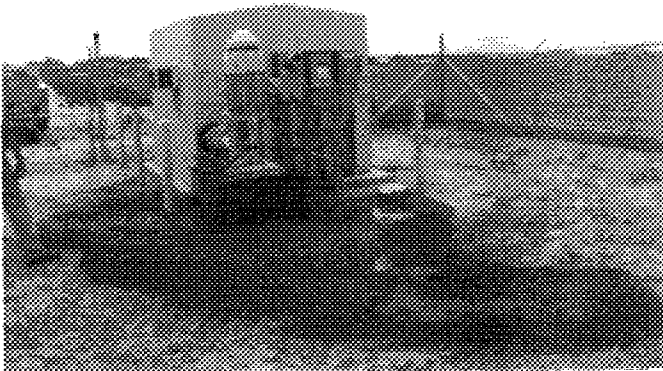
Photograph 10. Extraction Well E-102 (Northern Subunit C).
